Reserve Study Transmittal Letter

Re: Summerlin North Community Association; Update w/ Site Visit Review

RESERVE STUDY

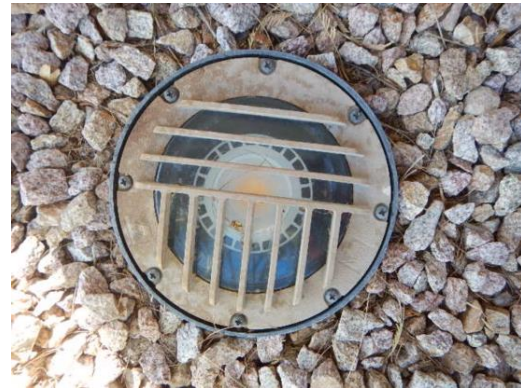
2024- Bollard lights not observed.
 2020- Missing lenses and lens rings observed. \$23,487 total was expended for miscellaneous lighting including Town Center/Canyon Run, south round-about, and other areas in 2016.

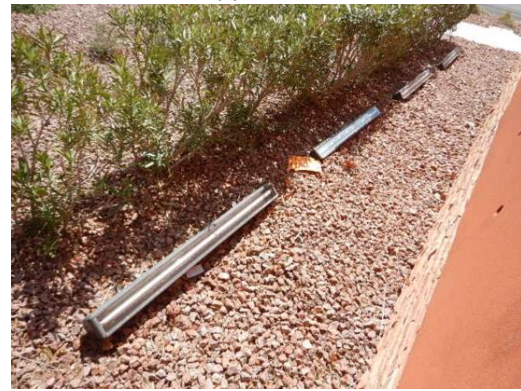
2024- \$3,723 was expended at Charleston monument in 2023.
 2020- Misaligned and 2 broken fixtures were observed at the Charleston monument.
 2015- 1 is broken and the others are misaligned at the Charleston Summerlin pyramid.

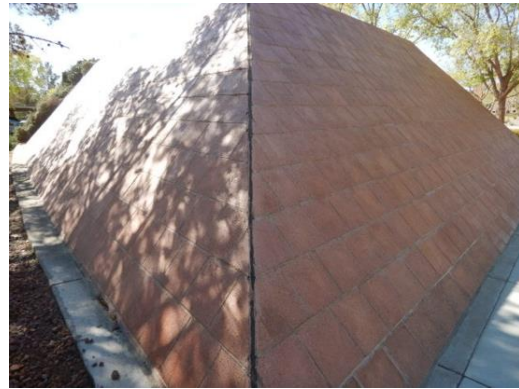
2015- The caulking has deteriorated. Each panel edge and the entire lengths of the base and top needs caulking.

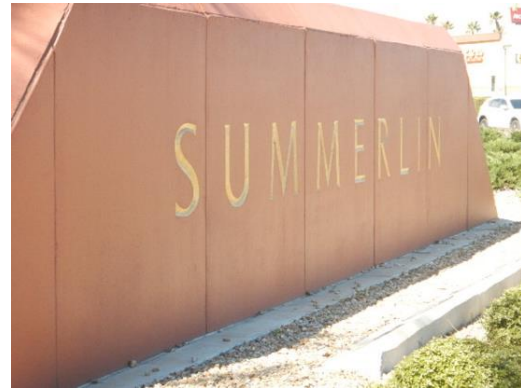
2020- Paint fade and bare spots were observed at the Charleston monument.
 2015- The prior study included Town Center monuments and 11 street monuments that are not included within Summerlin North. This component also groups the 3 pyramids together which were separate in the prior study.

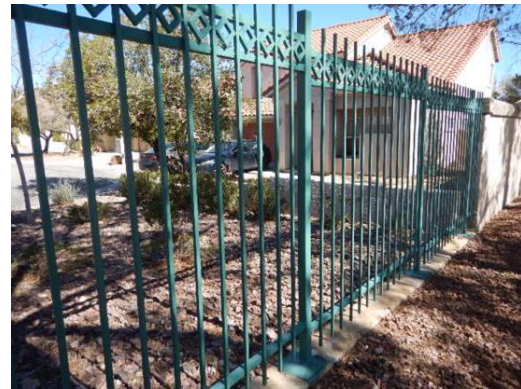
2024- Rust was observed.
 2020- Heavy rust and rust through was observed. Fence replacements are anticipated at several locations. Painted in approximately 2016.
 2015- Heavy rust was observed at Panorama and Visions.
 2012- Painted.

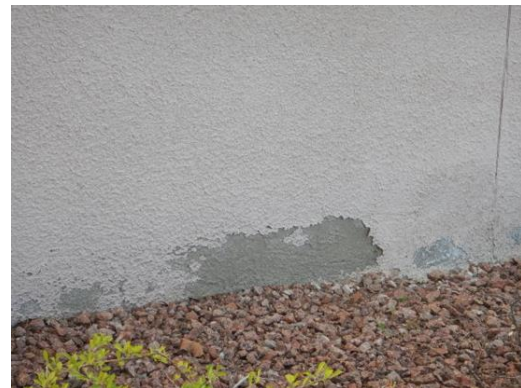
2020- Painted in approximately 2016. Spall and peeled paint was observed.
 2012- Painted.

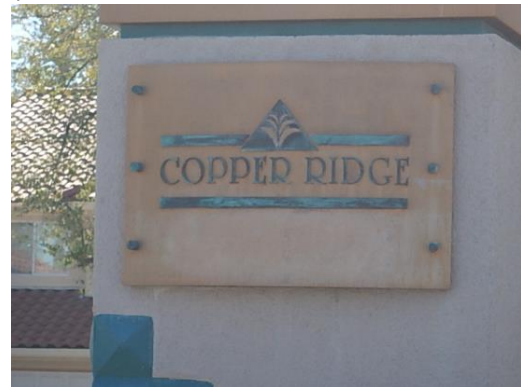
2020- The metal sign is dented at 3 spots and missing icon pieces.

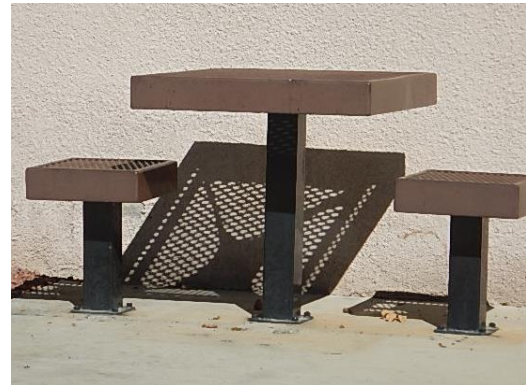
2024- The items are faded.

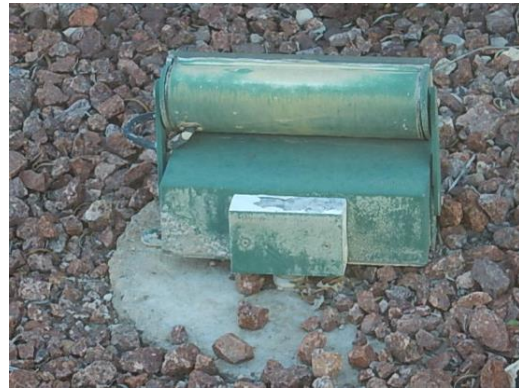
2020- Conditions vary with some lights misaligned and some with poor exterior finishes.

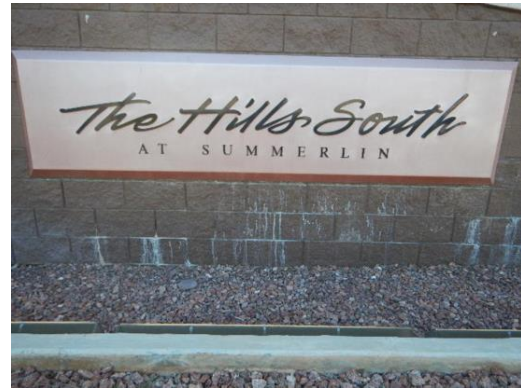
2024- The signs are functional but faded and the Village Center @ Hillshire monument block wall is cracked. The sign at Hills Center @ Hillpointe is missing a letter 'A'.
 2015- The surrounding landscape wall exhibit spall/peel.

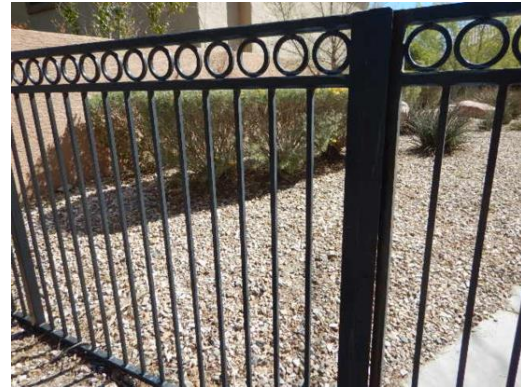
2024- Rust, stains, and fade were observed.
 2020- Painted in approximately 2018.

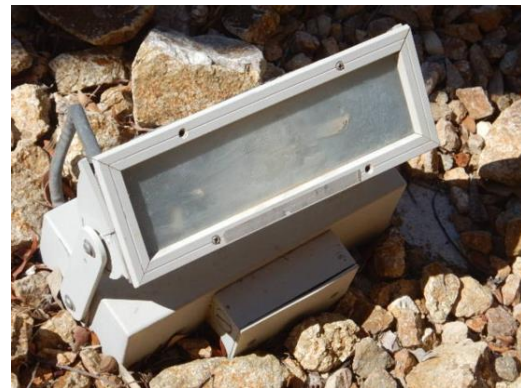
2024- \$5,145 was expended to replace all four Elliptipar fixtures at Pueblo Vista & Vegas Dr with LED fixtures in 2022. The Sedona monument light is damaged.

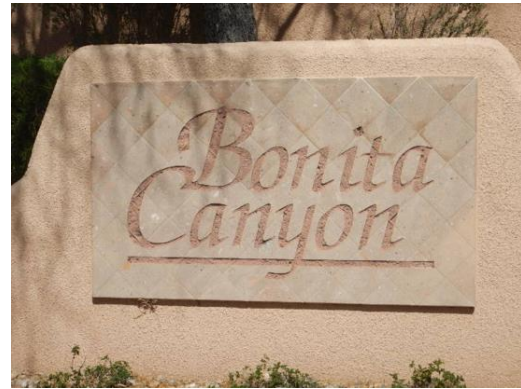
2024- The lettering paint is faded.

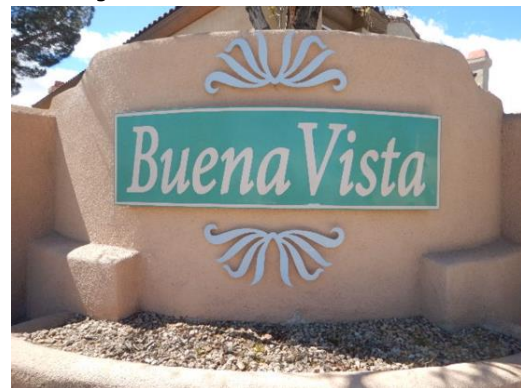
2020- The varnish layer is peeling off one sign and an icon is damaged on another.

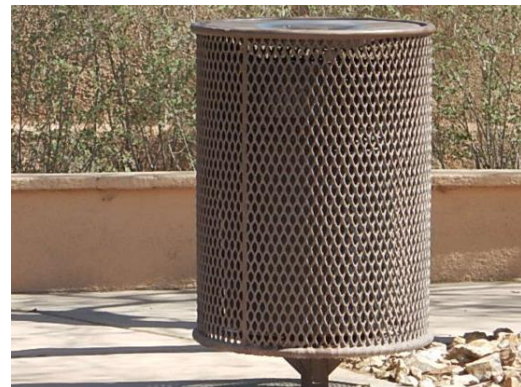
2020- Receptacles between Red Hills/Sonoma appeared faded.
 2015- The Cielo Vista park furnishings appeared to have been recently painted, and the Plateau appears recently replaced.
