Reserve Study Transmittal Letter

Re: Summerlin North Community Association; Update w/ Site Visit Review

RESERVE STUDY

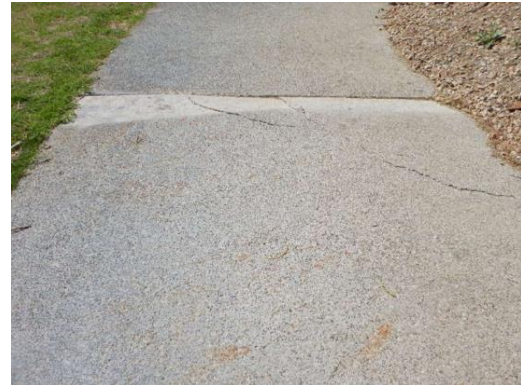
2024- Elevation shifts were observed with examples at mini parks including Copper Ridge and Glenmere.

2015- Ongoing concrete grinding was evident at several locations including Hillpointe and Cielo Vista park between Red Hills & Sonoma. Elevation shifts were observed at Copper Ridge.

2014- All uneven areas ground.

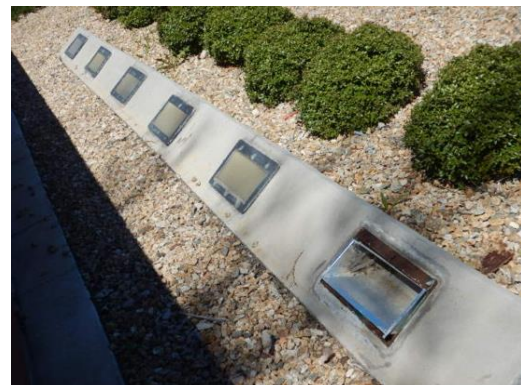
2024- One southwest monument light is damaged.

Lower right light is damaged.

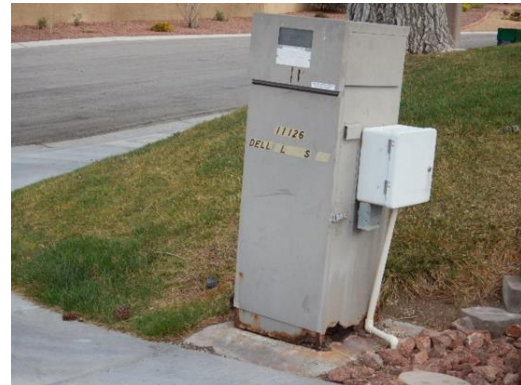
2024- Heavy rust was observed at several locations including Arbors Arbor View and Rosedale. Per client, recent replacements have been \$15,000 including \$5,000 for engineering, so increased estimate from \$4,730 to \$15,000.
 2020- Rust through was observed particularly for park area pedestals subjected to direct irrigation spray including Arbors Fallbrook/Brookfield/Rosedale parks.

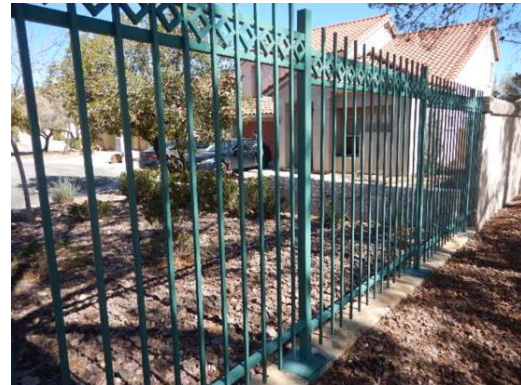
2024- \$14,000 total was expended for gates and fencing throughout Summerlin North in 2023. Increased useful life from 30 to 35 years and remaining life from 2025 to 2030. Combined prior two fence components.
 2020- \$52,080 is anticipated to replace various fence sections at approximately 50 locations.
 2015- Rust damage including rust through was observed at Panorama and Visions. Panorama also has missing pickets.

This is to replace the wrought iron fences and gates. With aggressive paint maintenance, this component's life may be extended. Painting and gate repairs provided for within other components.

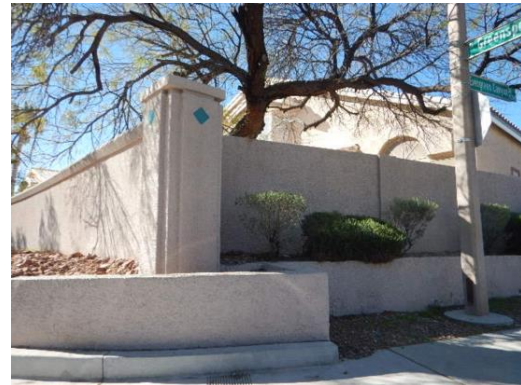
2024- \$91,016 total was expended to repair/replace various walls in throughout Summerlin North in 2023 plus \$18,408 in 2022. Cracks were observed along the Copper Ridge mini park walls and spall at the Visions mini park. Cracks and stucco spall were observed along the Willow Bend breezeway. Various spall and peeled paint was observed. Wall cracks exist at Star Mist @ Crestdale.
 2020- Cracks and peel/spall were observed at various locations. \$11,140 total expended including \$2,740 at Copper Ridge and \$8,400 at Lake Mead/Springfield in 2017.
 2015- Peel/spall were observed near Las Colinas and also between Cypress Grove and Valle Del Fiori.
 2012- Painted.

This is for ongoing stucco clad masonry wall maintenance in conjunction with the paint cycle. Since the core masonry wall useful life exceeds the scope of this thirty year study, this component provides for repair only and not full replacement. Maintenance may include crack repair, cap block repair, repointing, stucco spall/peel repair, and efflorescence removal. Painting is provided for within another component.

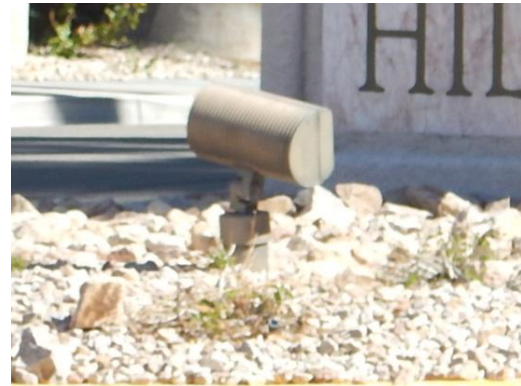
2020- Conditions vary with poor exterior finishes on some older Elliptipar fixtures.

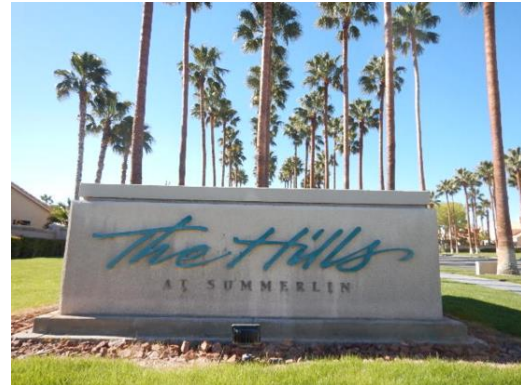
2024- Peeled paint and spalled stucco were observed on the monument walls.
 2020- Walls exhibit spall/peel.
 2015- The surrounding landscape walls exhibit heavy spall/peel.

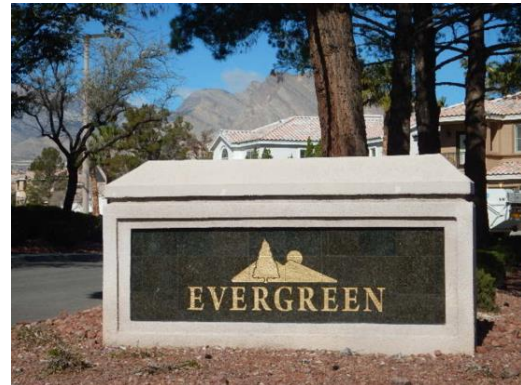
2024- \$5,695 was expended to refurbish in 2022.
 2020- The letter and icon varnish is peeled/cracked.

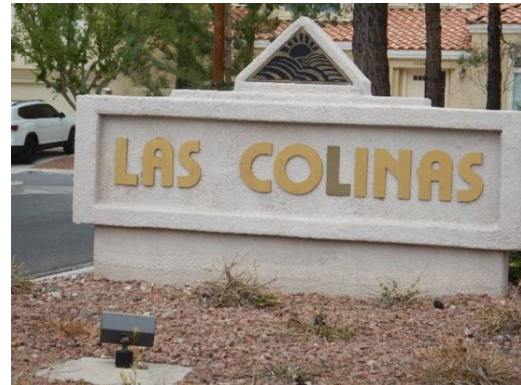
2024- The discolored 'L' remains.
 2020- The second 'L' appears discolored.

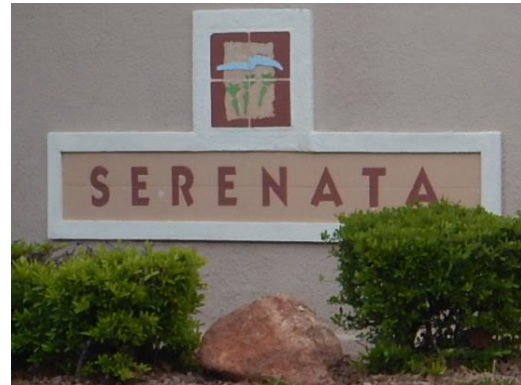
2024- Signs don't appear replaced. Stains and peeled paint observed.
 2020- Appears that these signs haven't been replaced.
 2015- Client advises that the glazed tile may be replaced with other materials.

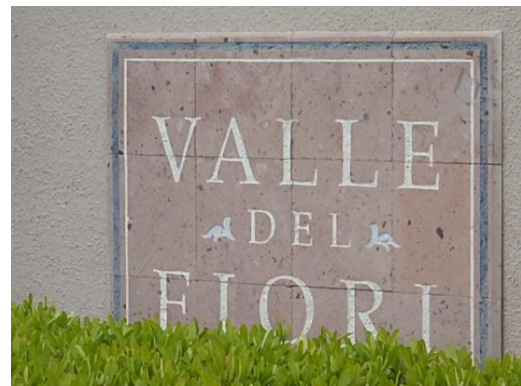
2020- Some paint overspray exists.

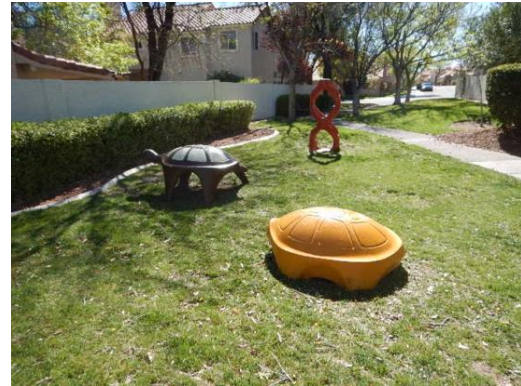
This is to replace the concrete turtles.
 2020- Could use some paint touchup.

110 - Tot Lot: Play Equipment	Useful Life 40	Remaining Life 7
3 Copper Ridge Park Concrete Turtles	Quantity 3	Unit of Measure Items
	Cost /Itm \$2,035	
	% Included 100.00%	Total Cost/Study \$6,105
Summary	Replacement Year 2031	Future Cost \$7,257

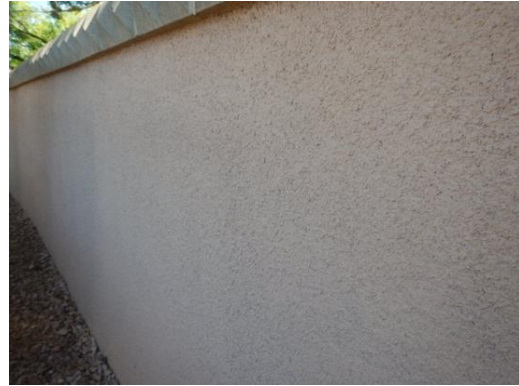
2020- Cracks and peel/spall were observed at various locations.

2015- Peel/spall was observed along the lower portions of these walls particularly where irrigation spay is present. The small retaining walls around the village monument signs exhibit a great deal of peel/spall.

This is for ongoing stucco clad masonry wall maintenance in conjunction with the paint cycle. Since the core masonry wall useful life exceeds the scope of this thirty year study, this component provides for repair only and not full replacement. Maintenance may include crack repair, cap block repair, repointing, stucco spall/peel repair, and efflorescence removal. Painting is provided for within another component.

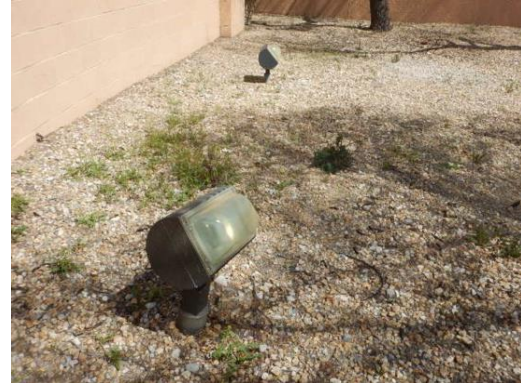
2024- \$5,145 was expended to replace all four Elliptipar fixtures at Pueblo Vista & Vegas Dr with LED fixtures in 2022. The Sedona monument light is damaged.

This is to periodically replace the monument sign light fixtures on a percentage basis. This component assumes that wiring and conduits will be reused.

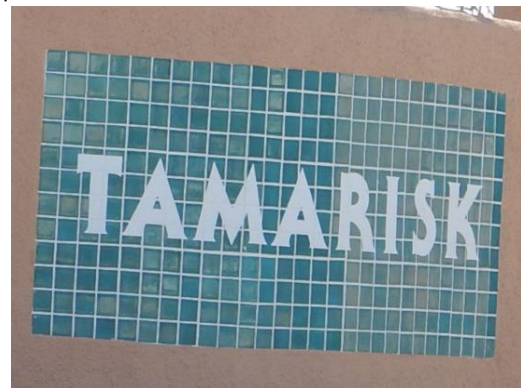
488 - Monument	Useful Life 8	Remaining Life 4	
2 Tamarisk Signs	Quantity 2	Unit of Measure	Items
	Cost /Itm \$3,293		
	% Included 100.00%	Total Cost/Study	\$6,587
Summary	Replacement Year 2028	Future Cost	\$7,270

- 2024- Signs don't appear replaced.
- 2020- Signs don't appear replaced.
- 2015- Per client, glazed tile may be replaced with another product.

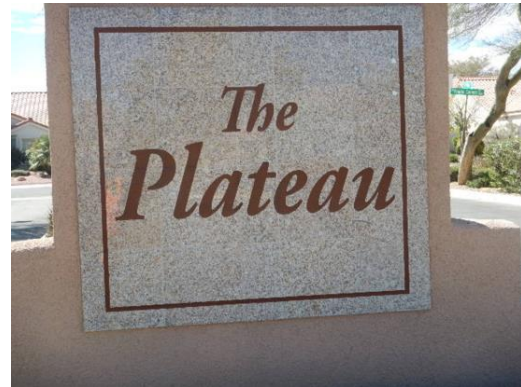
492 - Monument	Useful Life 8	Remaining Life 5	
The Plateau Sign	Quantity 1	Unit of Measure	Items
	Cost /Itm	\$3,293	
	% Included	100.00%	Total Cost/Study \$3,293
Summary	Replacement Year	2029	Future Cost \$3,726

2020- This monument appears to have been replaced since 2015. \$2,373 was expended in 2016.

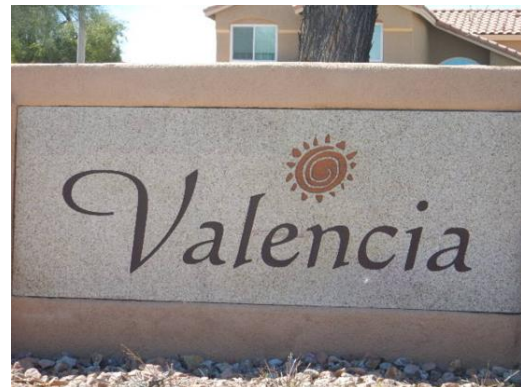
496 - Monument	Useful Life 8	Remaining Life 3	
Valencia Sign	Quantity 1	Unit of Measure	Items
	Cost /Itm	\$3,293	
	% Included	100.00%	Total Cost/Study \$3,293
Summary	Replacement Year	2027	Future Cost \$3,546

2020- The monument appears to have been refurbished since 2015.

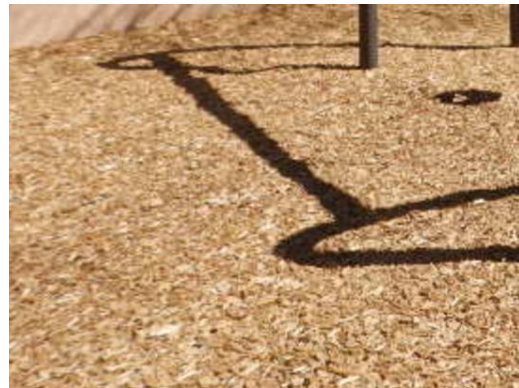
140 - Tot Lot: Safety Surface	Useful Life 10	Remaining Life 5
47 Cu. Yds. Cielo Vista Btwn Sonoma & Taos	Quantity 47	Unit of Measure Cubic Yard
	Cost /CuYd \$120	
	% Included 100.00%	Total Cost/Study \$5,640
Summary	Replacement Year 2029	Future Cost \$6,381

2024- Converted square feet area to cubic yard volume assuming 12" replenishment, so revised quantity from 1,250 sf to 47 cy.

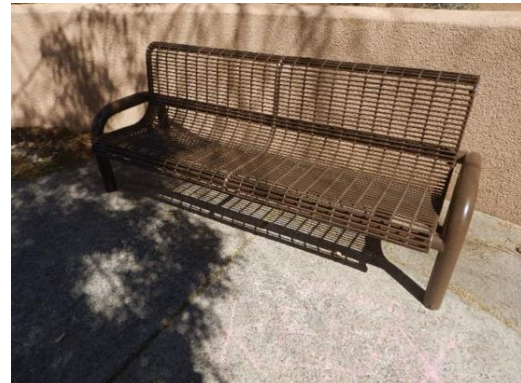
318 - Benches	Useful Life 4	Remaining Life 2	
16 Benches (25%)	Quantity 16	Unit of Measure	Items
	Cost /Itm \$1,278	Qty * \$/Itm	\$20,444
	% Included 25.00%	Total Cost/Study	\$5,111
Summary	Replacement Year 2026	Future Cost	\$5,370

2020- Benches between Red Hills/Sonoma appeared faded.
 2015- The Cielo Vista park furnishings appeared to have been recently painted.

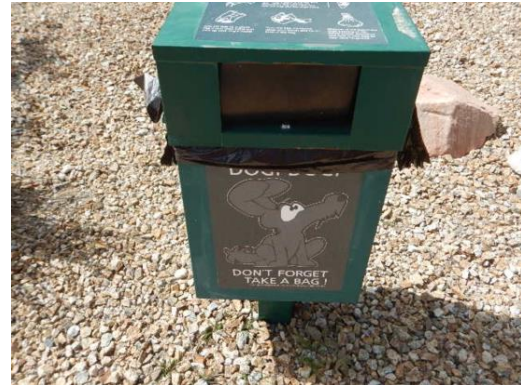
378 - Pet Stations	Useful Life 4	Remaining Life 1	
9 Pet Stations (25%)	Quantity 9	Unit of Measure	Items
	Cost /Itm \$785	Qty * \$/Itm	\$7,065
	% Included 25.00%	Total Cost/Study	\$1,766
Summary	Replacement Year 2025	Future Cost	\$1,810

2024- Cielo Vista park pet station exhibits heavy rust.
 2020- Cielo Vista park pet station exhibits heavy rust.

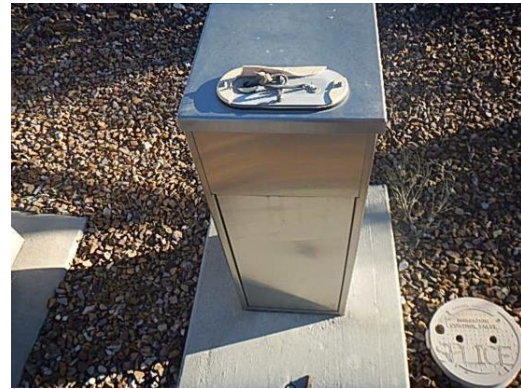
124 - Irrigation: Controllers	Useful Life 10	Remaining Life 1
20 Timeclocks	Quantity 20	Unit of Measure Items
	Cost /Itm \$2,439	
	% Included 100.00%	Total Cost/Study \$48,777
Summary	Replacement Year 2025	Future Cost \$49,996

2024- One antenna enclosure was damaged.
 2013/2014- All controllers were retrofitted by Aqua Management Inc under a fixed cost arrangement that covers all repair and replacements for approximately 10 years after which the association will own the controllers. The association is responsible for controller operation.

Broken antenna enclosure.

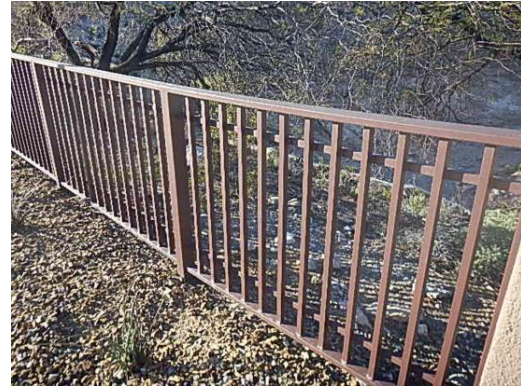
232 - Wrought Iron	Useful Life 35	Remaining Life 8	
1,400 lf Fences	Quantity 1,400	Unit of Measure Linear Feet	
	Cost /l.f. \$77.00		
	% Included 100.00%	Total Cost/Study \$107,800	
Summary	Replacement Year 2032	Future Cost \$131,344

2024- \$14,000 total was expended for gates and fencing throughout Summerlin North in 2023. \$8,695 was expended to replace 47 lf along linear park near Summerlin Pkwy and TPC golf course in 2022. Increased useful life from 30 to 35 years and remaining life from 2027 to 2032.

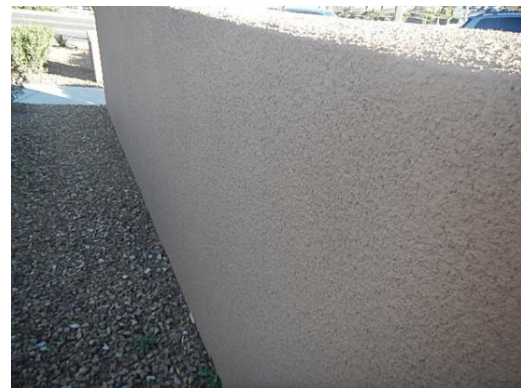
440 - Masonry Wall: On-going Maint.	Useful Life 5	Remaining Life 3	
34,636 lf Stucco Clad Block Walls (0.3%)	Quantity 34,636	Unit of Measure Linear Feet	
	Cost /l.f. \$264	Qty * \$/l.f. \$9,126,586	
	% Included .30%	Total Cost/Study \$27,380	
Summary	Replacement Year 2027	Future Cost \$29,485

2024- \$91,016 total was expended to repair/replace various walls in throughout Summerlin North in 2023 plus \$18,408 in 2022.
 2014- Painted.

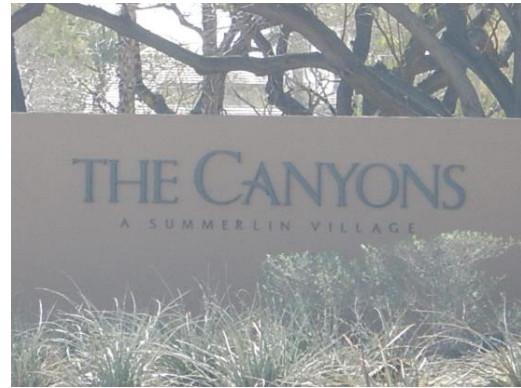
324 - Monument	Useful Life 8	Remaining Life 7	
9 Canyons Village Monument Refurbish	Quantity 9	Unit of Measure	Items
	Cost /Itm \$4,730		
	% Included 100.00%	Total Cost/Study	\$42,573
Summary	Replacement Year 2031	Future Cost	\$50,606

2024- Per client 5/31/2024, the village monuments were refurbished during 2023.

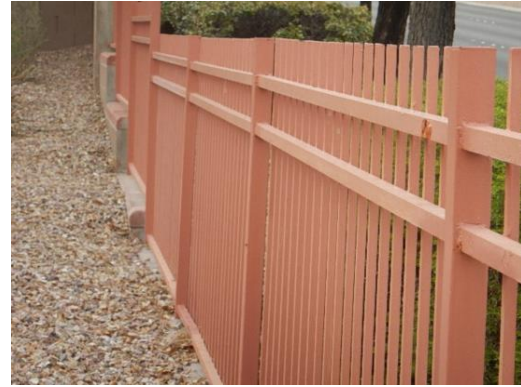
416 - Wrought Iron	Useful Life 5	Remaining Life 2	
1,689 lf WI Fences	Quantity 1,689	Unit of Measure	Linear Feet
	Cost /l.f. \$5.42		
	% Included 100.00%	Total Cost/Study	\$9,154
Summary	Replacement Year 2026	Future Cost	\$9,618

2020- Painted in approximately 2018.
 2015- The Highpointe fence exhibited rust.
 2011- Painted.

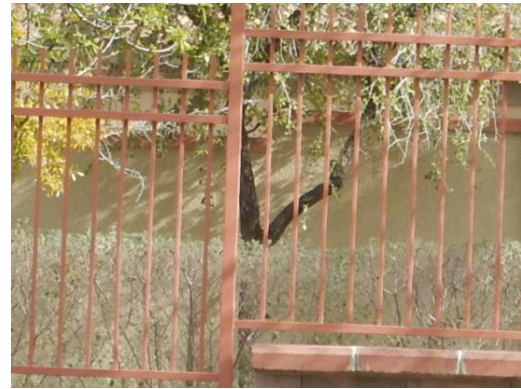
240 - Wrought Iron	Useful Life 35	Remaining Life 5	
1,689 lf Fences	Quantity 1,689	Unit of Measure	Linear Feet
	Cost /l.f. \$77.00		
	% Included 100.00%	Total Cost/Study	\$130,053
Summary	Replacement Year 2029	Future Cost	\$147,143

2024- \$14,000 total was expended for gates and fencing throughout Summerlin North in 2023. Increased useful life from 30 to 35 years and remaining life from 2024 to 2029.
 2015- The Willow Bend breeze way fence is rusted through and unstable.

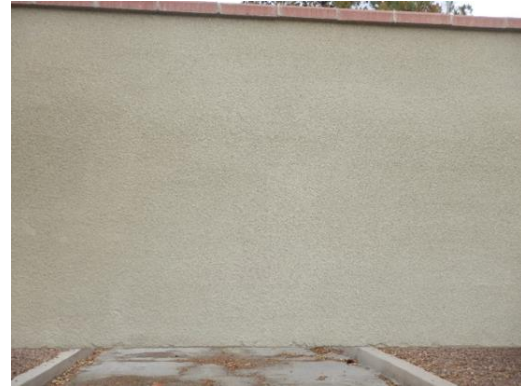
460 - Masonry Wall: On-going Maint.	Useful Life 5	Remaining Life 2
41,131 lf Stucco Clad Block Walls (0.3%)	Quantity 41,131	Unit of Measure Linear Feet
	Cost /l.f. \$264	Qty * \$/l.f. \$10,838,019
	% Included .30%	Total Cost/Study \$32,514
Summary	Replacement Year 2026	Future Cost \$34,160

2024- \$91,016 total was expended to repair/replace various walls in throughout Summerlin North in 2023 plus \$18,408 in 2022. Cracks exist in the Highpointe mini park wall.
 2024- \$91,016 total was expended to repair/replace various walls in throughout Summerlin North in 2023.
 2020- Sequoia entry area walls exhibit cracks and a large peel area. \$2,219 total was expended at Highpointe mini-park and Sunset Crest entry.
 2011- Painted.

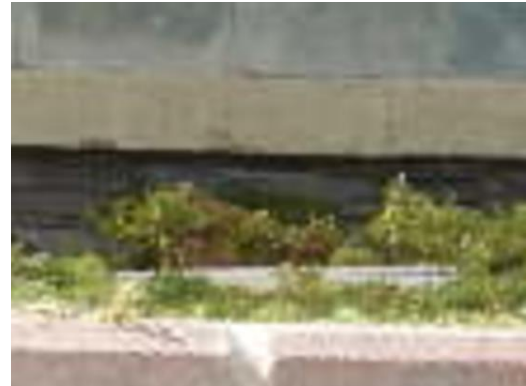
2020- A Highpointe monument light is damaged.

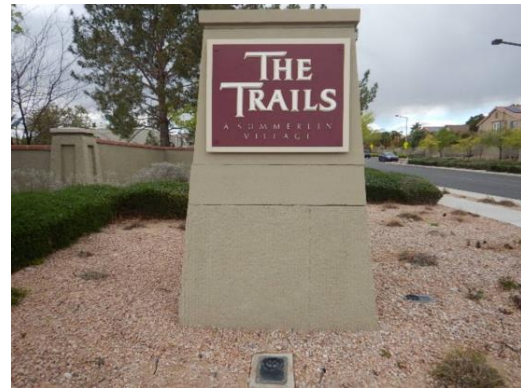
2024- The monuments are faded.
 2020- \$3,162 was expended in 2016.

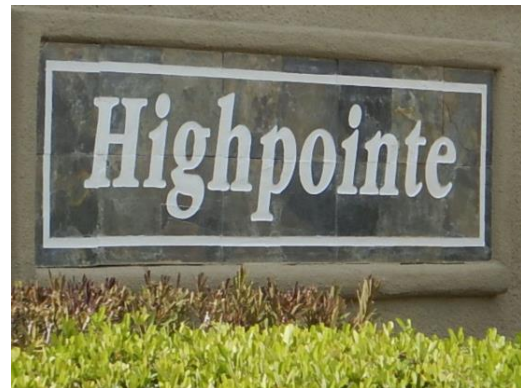
2024- \$895/each was expended to refurbish in 2023.
 2020- One monument exhibits rust stains on one tile.

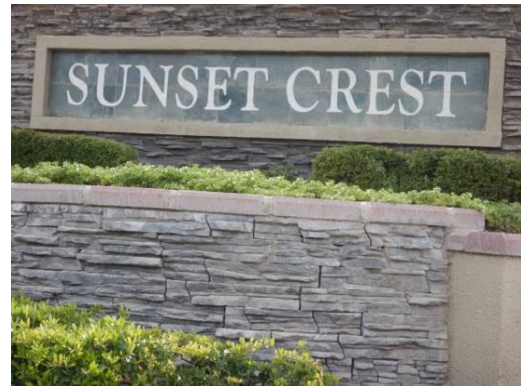
2020- Some overspray observed.

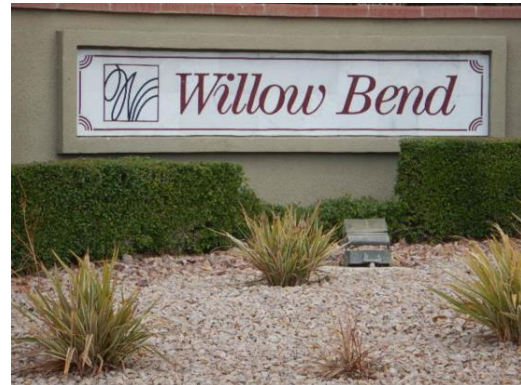
2024- \$20,364 was expended in 2021.
 2020- Signs appeared faded and one has minor damage.

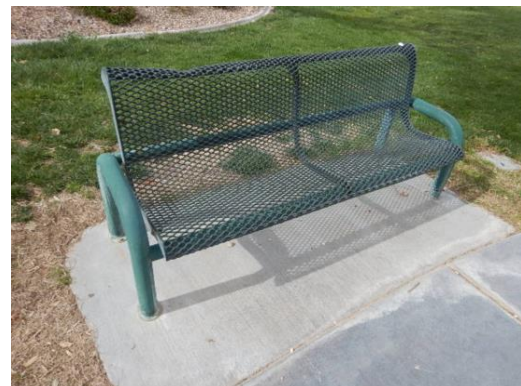
2015- A Highpointe bench exhibited rust.

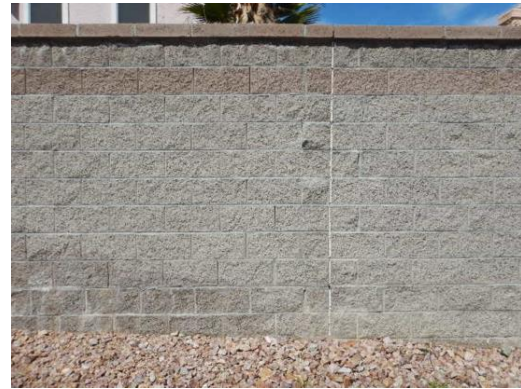
2024- Manorwood mini park block walls have deep spall.
 2020- Hillpointe entry area retaining wall cap block issues observed.

This is for ongoing split face masonry wall maintenance. These walls are unpainted. Since the core masonry wall useful life exceeds the scope of this thirty year study, this component provides for repair only and not full replacement. Maintenance may include crack repair, cap block repair, repointing, and efflorescence removal.

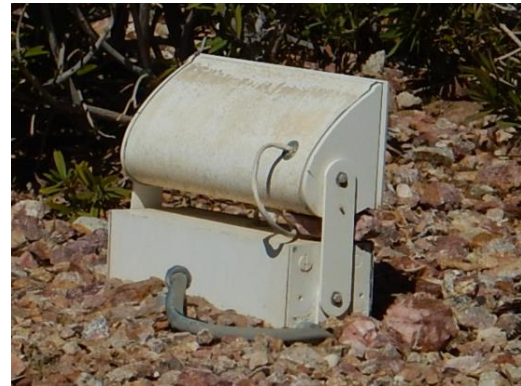
2020- Discovery Hills lens shattered.

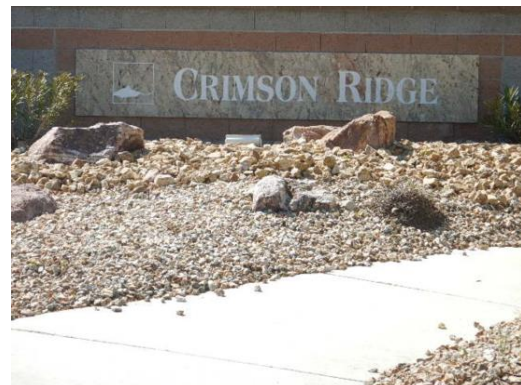
2020- Several cracked/chipped tiles were observed.

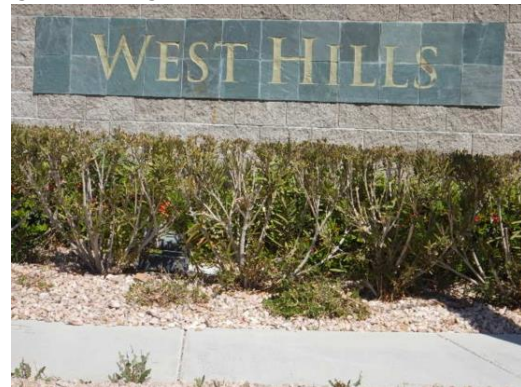
2024- Some slightly off-color tile, missing grout, and faded gold lettering were observed.

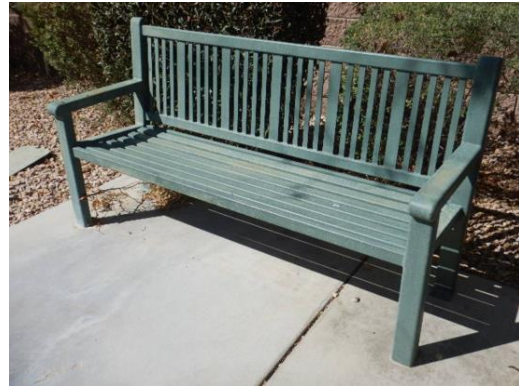
2024- The Discovery Hills mini park bench paint is faded.

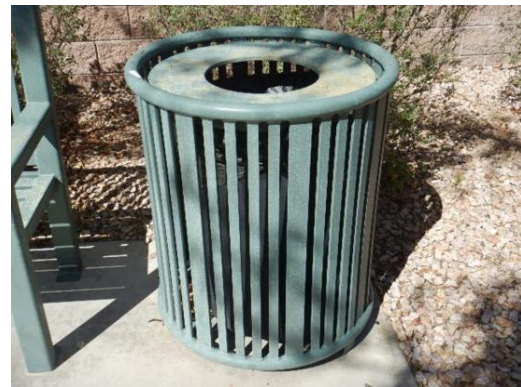
2024- The Discovery Hills mini park receptacle paint is faded.

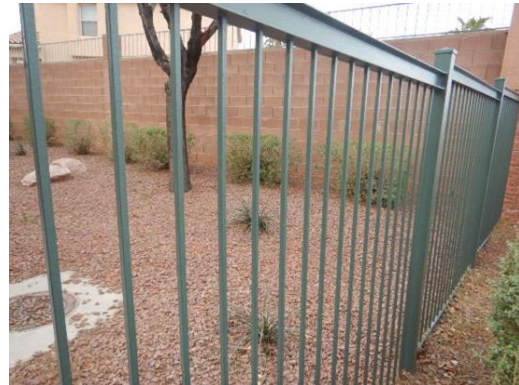
2020- Brookfield park fence and furnishings exhibit heavy rust. Village monument arbors exhibit rust and peel.

2015- Fence rust was observed at Brookfield. Monument arbor paint is peeling and the metal is rusted. Painting is anticipated.

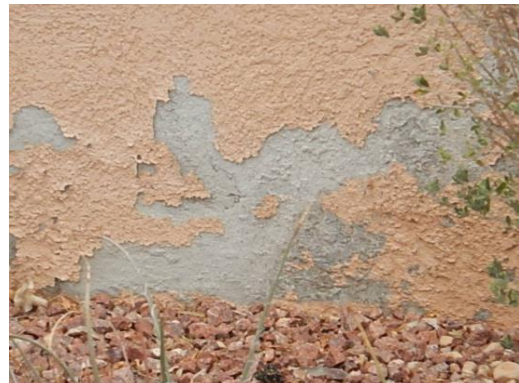
2020- Minor stucco/paint damage along lower edges of walls was observed including mini-park walls and Fallbrook entry walls. Efflorescence was observed at several locations including Manorwood mini-park.

2015- Stucco damage was observed at Manorwood. Painting is anticipated.

This is to prepare and paint the masonry walls. Repairs typically performed in conjunction with painting are provided for within another component.

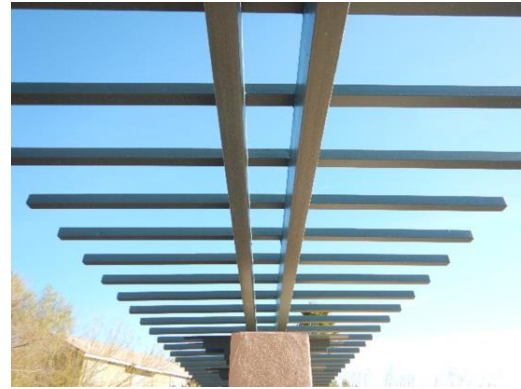
300 - Trellis 10 Monument Metal Lattice	Useful Life 40 Quantity 10 Cost /Itm \$1,900 % Included 100.00%	Remaining Life 15 Unit of Measure Items Total Cost/Study \$19,000 Replacement Year 2039 Future Cost \$27,518
--	--	--

This is to repair and replace the monument metal lattice. With aggressive paint maintenance, this component's life may be extended.

2015- The paint is peeling.

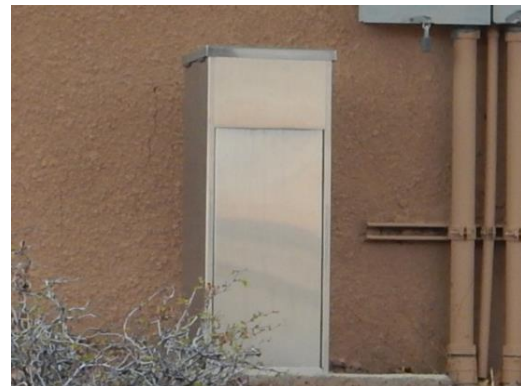
146 - Irrigation: Controllers 55 Timeclocks	Useful Life 10 Quantity 55 Cost /Itm \$2,439 % Included 100.00%	Remaining Life 1 Unit of Measure Items Total Cost/Study \$134,137 Replacement Year 2025 Future Cost \$137,490
--	--	---

This is to replace the internet accessible irrigation controllers.

2013/2014- All controllers were retrofitted by Aqua Management Inc under a fixed cost arrangement that covers all repair and replacements for approximately 10 years after which the association will own the controllers. The association is responsible for controller operation.

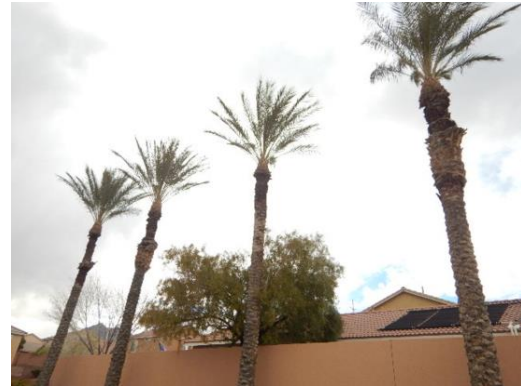
45- neighborhood

558 - Plant Replacement	Useful Life 5	Remaining Life 10
45 Palm Trees (4%)	Quantity 45	Unit of Measure Items
	Cost /Itm \$6,775	Qty * \$/Itm \$304,875
	% Included 4.44%	Total Cost/Study \$13,550
Summary	Replacement Year 2034	Future Cost \$17,345

This is to periodically replace mature palm trees on a percentage basis beginning at approximately 35 year age.

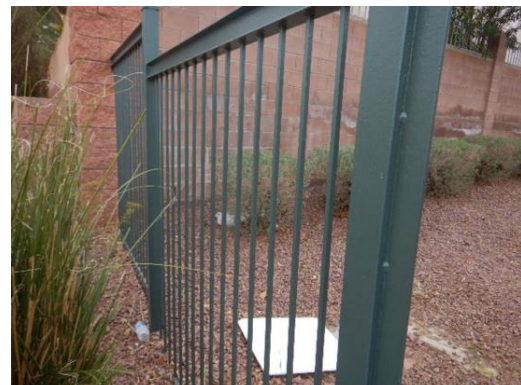
264 - Wrought Iron	Useful Life 35	Remaining Life 6
13,966 lf Phase I & II Fences	Quantity 13,966	Unit of Measure Linear Feet
	Cost /l.f. \$77.00	
	% Included 100.00%	Total Cost/Study \$1,075,382
Summary	Replacement Year 2030	Future Cost \$1,247,113

This is to replace the wrought iron fences and gates. With aggressive paint maintenance, this component's life may be extended. Painting and gate repairs provided for within other components.

2024- \$1,911 was expended to replace the Brookfield mini park fence railing per CEDCO 3/28/2024 proposal. \$14,000 total was expended for gates and fencing throughout Summerlin North in 2023. Added Rosedale tot lot fence, so increased phase II quantity from 2,584 to 2,725 lf. Increased useful life from 30 to 35 years and remaining life from 2025 to 2030. Combined phase I and II components. Per client 2020- Sonoma Park fence pickets are missing.

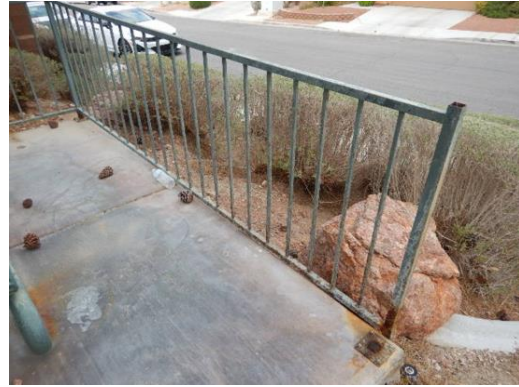
2024- \$1,911 was expended to replace the Brookfield mini park fence railing per CEDCO 3/28/2024 proposal.

Brookfield mini park railing that was replaced during 2024.

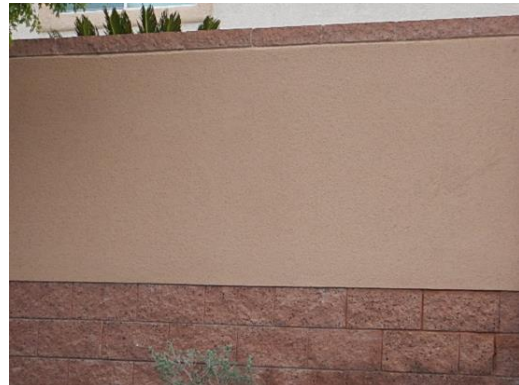
480 - Masonry Wall: On-going Maint.	Useful Life 5	Remaining Life 3	
72,758 lf Stucco Clad Block Walls (0.3%)	Quantity 72,758	Unit of Measure Linear Feet	
	Cost /l.f. \$264	Qty * \$/l.f. \$19,171,733	
	% Included .30%	Total Cost/Study \$57,515	
Summary	Replacement Year 2027	Future Cost \$61,938

This is for ongoing partially stucco clad masonry wall maintenance in conjunction with the paint cycle. Since the core masonry wall useful life exceeds the scope of this thirty year study, this component provides for repair only and not full replacement. Maintenance may include crack repair, cap block repair, repointing, stucco spall/peel repair, and efflorescence removal. Painting is provided for within another component.

2024- \$91,016 total was expended to repair/replace various walls in throughout Summerlin North in 2023 plus \$18,408 in 2022. Painting was completed in 2022. Rosedale mini park stucco spall observed.
 2020- Chardonnay entry area retaining wall cap block issues observed. Napa Hills entry wall stucco has peeled off.
 2015- Spall/peel was observed. Painting is anticipated.

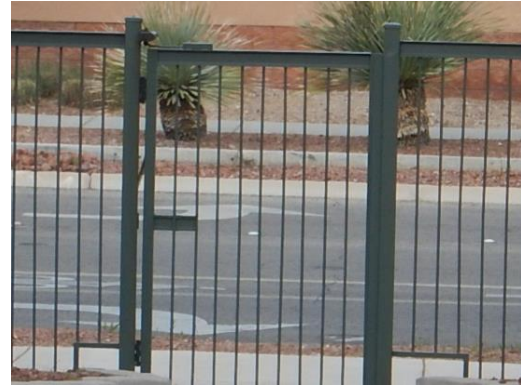
750 - Gates	Useful Life 5	Remaining Life 3
11 Breezeway Gates (27%)	Quantity 11	Unit of Measure Items
	Cost /Itm \$1,075	Qty * \$/Itm \$11,825
	% Included 27.27%	Total Cost/Study \$3,225
Summary	Replacement Year 2027	Future Cost \$3,473

2024- \$14,000 total was expended for gates and fencing throughout Summerlin North in 2023.
 2015- 2 Chardonnay Ridge gates were either misaligned or had broken return springs.

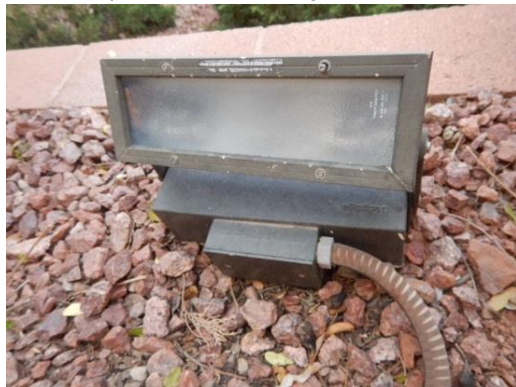
344 - Monument Lights	Useful Life 4	Remaining Life 2
28 Neighborhood Monument Lights (25%)	Quantity 28	Unit of Measure Items
	Cost /Itm \$1,825	Qty * \$/Itm \$51,100
	% Included 25.00%	Total Cost/Study \$12,775
Summary	Replacement Year 2026	Future Cost \$13,422

2024- \$3,543 was expended to replace both Napa Hills lights in 2023.
 2020- Conditions vary with some lights misaligned and some with poor exterior finishes. A Napa Hills monument light is damaged.
 2015- A Chardonnay Hills light was damaged. This light is within the pedestrian area adjacent to a bench.

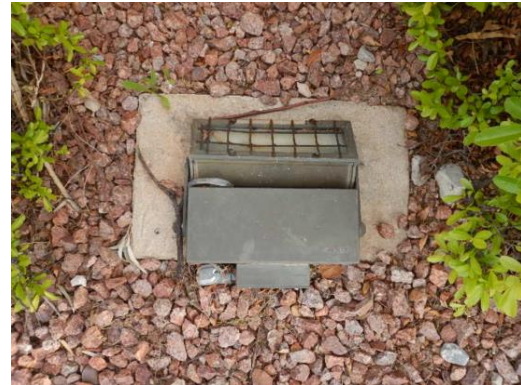
352 - Monument Lights	Useful Life 5	Remaining Life 2	
40 Village Monument Lights (25%)	Quantity 40	Unit of Measure	Items
	Cost /Itm \$599	Qty * \$/Itm	\$23,951
	% Included 25.00%	Total Cost/Study	\$5,988
Summary	Replacement Year 2026	Future Cost	\$6,291

2024- One light is damaged at Far Hills @ Anasazi.

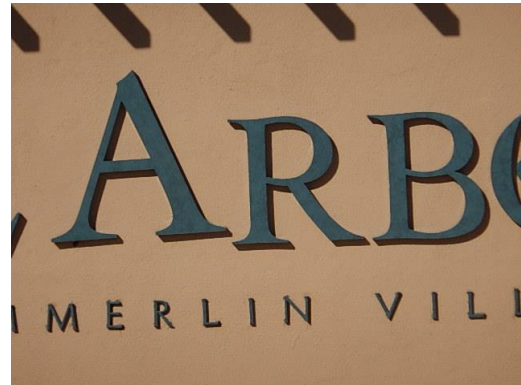
2024- \$714 was expended to replace missing letter 'I' (Anasazi @ Greenmoor) in 2023. The 'A' in Arbors is shifted at one Town Center @ Alta monument.
 2020- Metal trellis rust was observed. \$785 was expended in 2018.

Shifted 'A' letter which is not typical of other Arbors monuments.

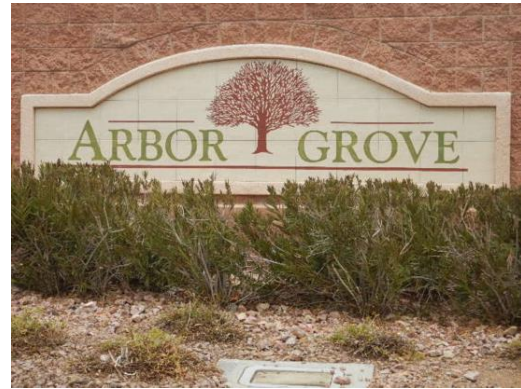
1- Banburry Cross @ Arbor Park

2020- Some minor peel was observed.

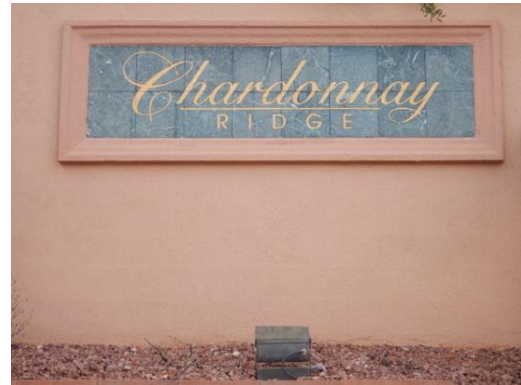
2- Greenmoor @ Pearl Vista

2024- \$895/each was expended to refurbish in 2023.
 2020- Lettering is difficult to distinguish.
 2015- Some minor stucco damage exists.

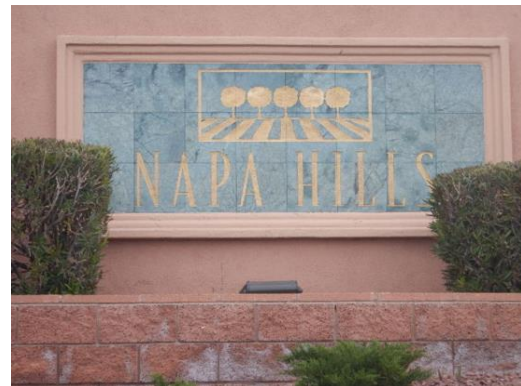
2- Sageberry @ Napa Hills

2024- \$895/each was expended to refurbish in 2023.
 2015- A tile has broken free.

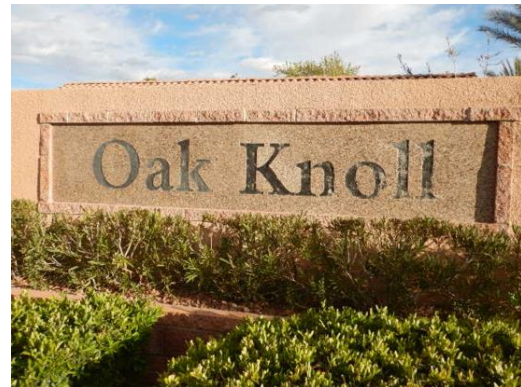
2- Greenmoor @ Dart

2024- Lettering paint is faded.

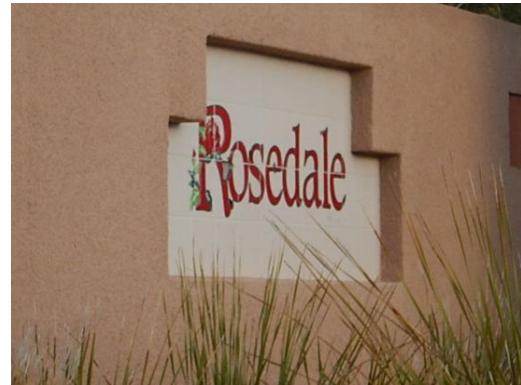
2- Sageberry @ Desert Dove

2024- \$8,301 total was expended to replace both signs per Wright Ventures, LLC 4/18/2024 proposal.
 2020- Signs don't appear replaced.
 2015- Per client, glazed tile may be replaced with another product.

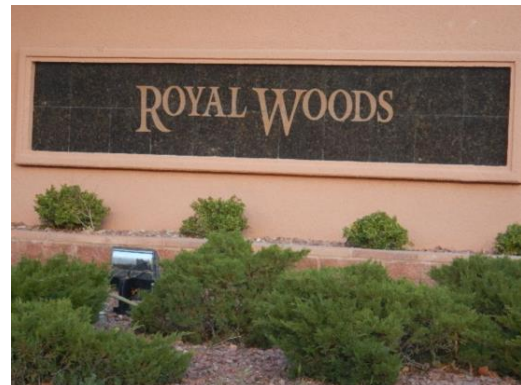
2- Laurelglen @ Royal Spruce

2024- Cracked tile was observed.
 2020- Some cracked tiles were observed.

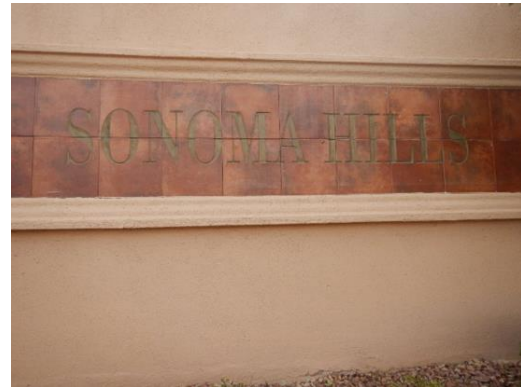
2- Sageberry @ Desert Dove

2024- Lettering is difficult to distinguish.

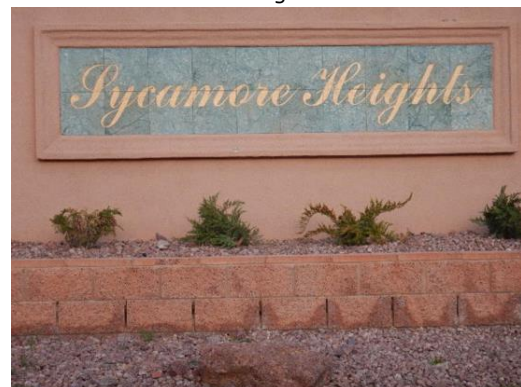
2024- Lettering is difficult to distinguish.

2020- Monuments appeared to have been rehabbed since 2015. Minor stucco damage was observed.

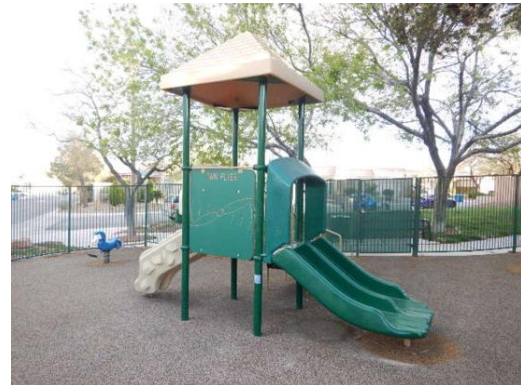
2024- Refurbished or replaced since 2020. \$4,728 was expended to replace one double wide slide plus \$800 to relocate spring rider in 2023.

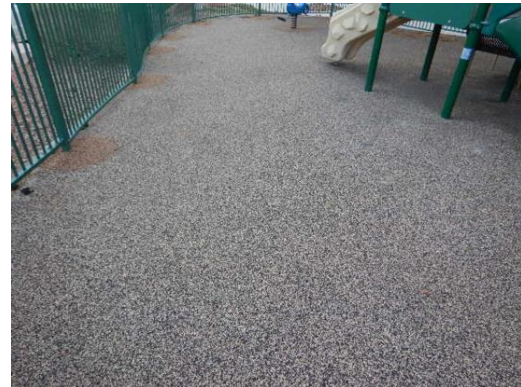
This is to replace the play area impact absorbing safety surface. Tears, cracks and other damage should be patched immediately. Poured in place surfaces should be seal coated every 2 to 3 years.

2024- \$750 was expended to patch surface plus \$1,700 to patch surface around new fence posts and relocated spring rider in 2023.
 2020- Rubber safety surface installed since 2015. \$5,107 was expended for park work in 2017.

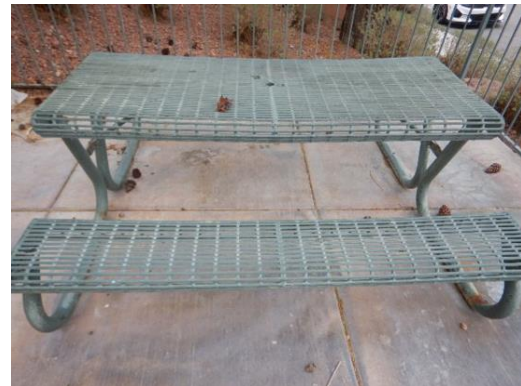
2024- Brookfield tables have a poor appearance and are rusted. Royal Wood's table is fire damaged.
 2020- Royal Woods' table is damaged, and Brookfield's are heavily rusted.

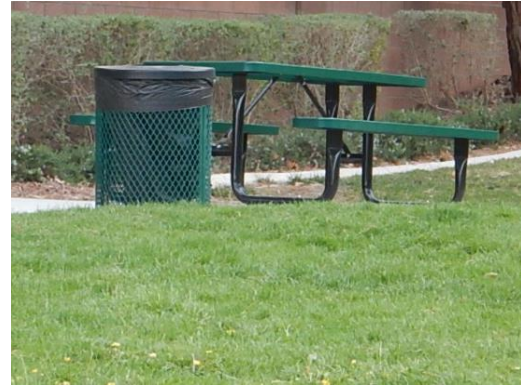
1- Fallbrook

2024- The prior concrete picnic table has been replaced with a metal table.

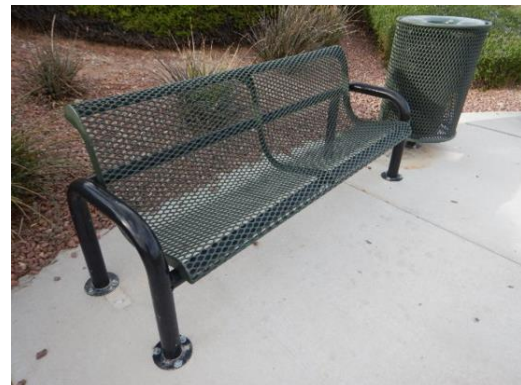
2024- Prior Fallbrook concrete bench replaced with metal bench, so increased quantity from 20 to 21.
 2020- \$3,405 total was expended for various outdoor furnishings throughout the Arbors in 2017.
 2015- A Chardonnay Ridge bench exhibited minor damage.

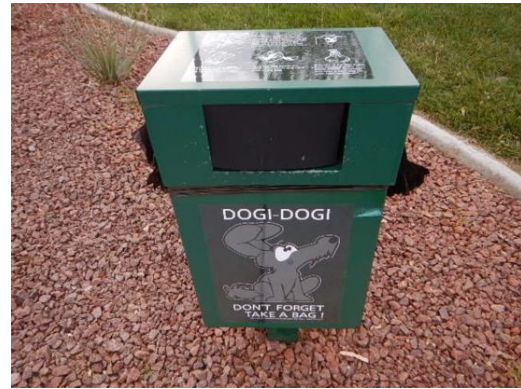
2020- Arbor View park pet station exhibits heavy rust.
 2015- A Fallbrook pet station exhibited heavy rust.

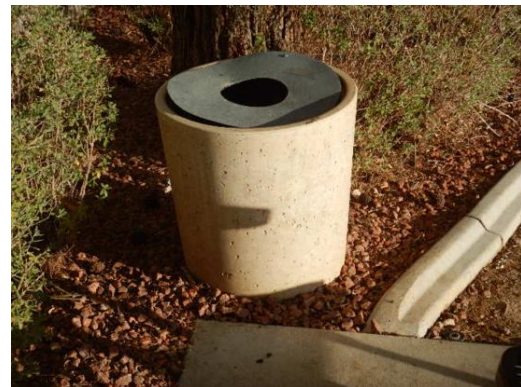
2024- The prior Fallbrook concrete receptacles have been replaced with metal receptacles.
 2020- One Fallbrook receptacle is cracked down one side.

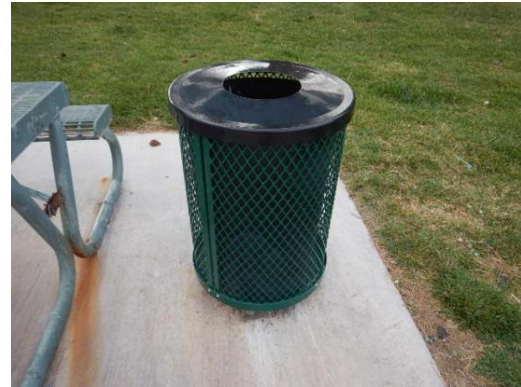
2024- Prior 2 Fallbrook concrete receptacles have replaced with metal, so increased quantity from 22 to 24.
 2020- Napa Hills needs paint and Brookfield missing top.

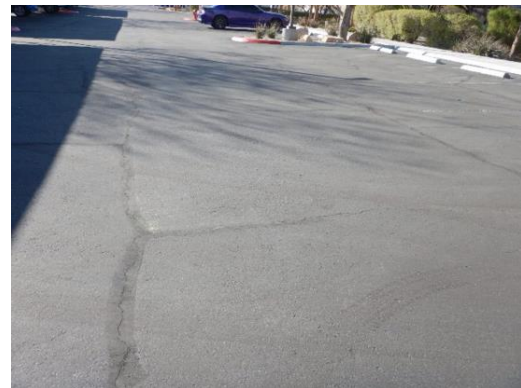
2024- \$3,504 total was expended prepare, crack fill, 2-coat seal, restripe, etc in 2022.
 2020- Due for seal coat.
 2014- Seal coated.

This is to prepare the surface and apply a single coat asphalt emulsion product. If a second coat is desired the cost is generally 10% to 20% higher.

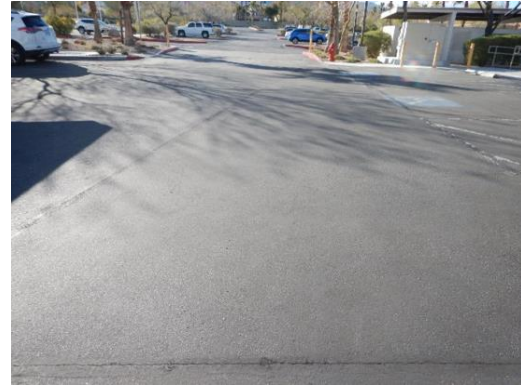
2024- \$3,504 total was expended prepare, crack fill, 2-coat seal, restripe, etc in 2022.
 2020- Minor unfilled cracks exist.

This is for miscellaneous repairs including crackfill, skin patching and minor dig out & fill. Cracks 1/4" or wider should be filled when observed.

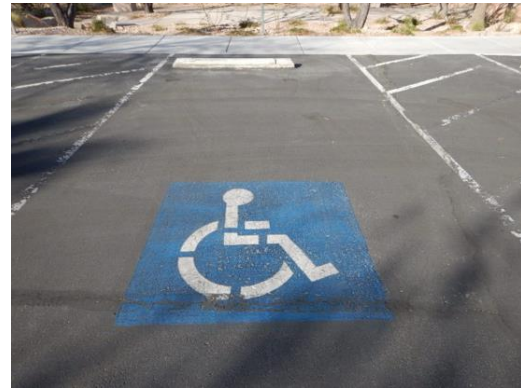
2024- \$3,504 total was expended prepare, crack fill, 2-coat seal, restripe, etc in 2022.
 2020- Faded.

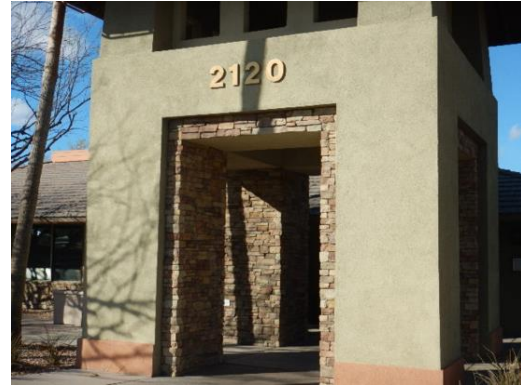
2020- Fascia and conduit touchup and overhang power wash are anticipated.
 2015- Some very minor nicks and stains were observed.

This is to prepare, power wash, sand, scrape, caulk and paint with a 100% premium acrylic paint. The building and structure are protected by a 6' roof overhang.

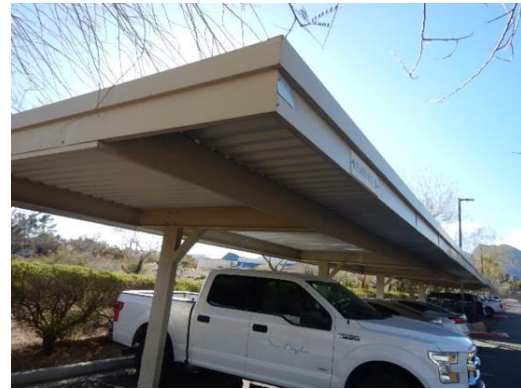
2020- Minor roof panel damage observed.

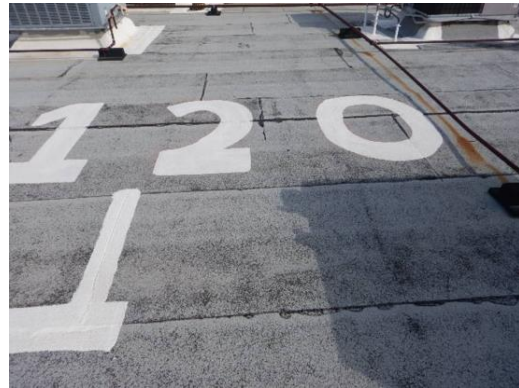
2020-A blister was observed at the northeast area approximately 7' from east wall and 20' from north wall. Several recent patches and some split seams were observed. The roof hatch opening has had metal flashings added which were fastened with self-tapping screws that protrude well into the hatch area where they present a sharp hazard to personnel accessing the roof.

2015- Prior repairs were evident. Open/split seams were observed. Parapet wall flashing screws are backing out.

2024- Revised low slope roofing approach from total replacement to an alternating coating and replacement cycle. Extended replacement useful life from 18 to 28 years and remaining life from 2024 to 2035 plus added a coating component beginning in 2025.

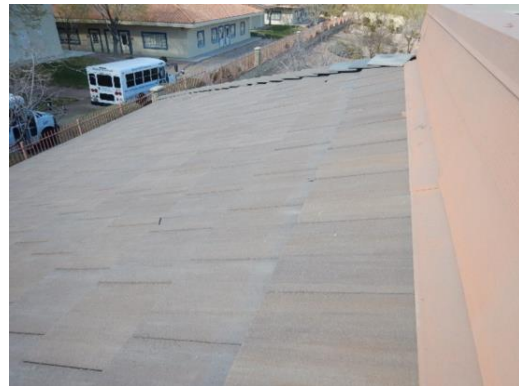
2024- Protective measures have been implemented to protect the entry structure from the palm tree contact.
 2020- Most prior issues have been repaired except that the palm trees are still in contact with the entry structure.
 2015- Serious issues were observed. Palm trees are rubbing the entry structure. The topmost tile course around the parapet wall and along hip ridges have slipped out of place exposing the underlayment. Hip ridge tiles are missing or loose.

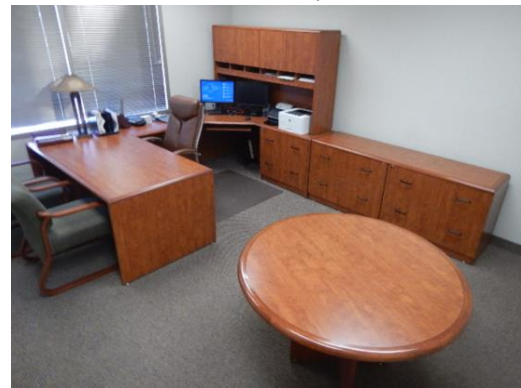
640 - Modular Office Desk	Useful Life 25	Remaining Life 7	
10 Office Cubes	Quantity 10	Unit of Measure	Items
	Cost /Itm \$4,600		
	% Included 100.00%	Total Cost/Study	\$46,000
Summary	Replacement Year 2031	Future Cost	\$54,680

This is to replace the modular office systems including desktops, hutches, drawers and partitions.

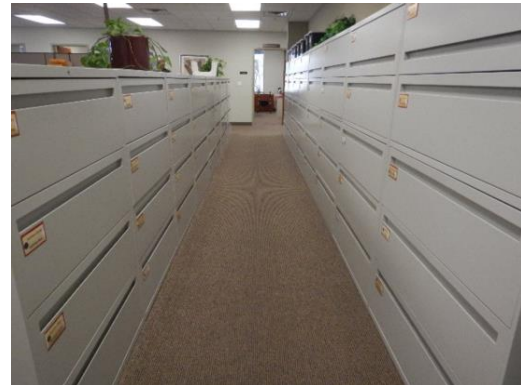
664 - Storage	Useful Life 30	Remaining Life 12
20 Bookcases, Cabinets, Shelves, Etc	Quantity 20	Unit of Measure Items
	Cost /Itm \$610	
	% Included 100.00%	Total Cost/Study \$12,194
Summary	Replacement Year 2036	Future Cost \$16,400

This is to replace miscellaneous bookcases, cabinets, shelves, cadenzas and entertainment hutch.
